**Firmware Version:** V4.00.024  
**Prom Code Version:** V4.00.002  
**Published:** Jan 13, 2012

These release notes include important information about D-Link switch firmware revisions. Please verify that these release notes are correct for your switch:

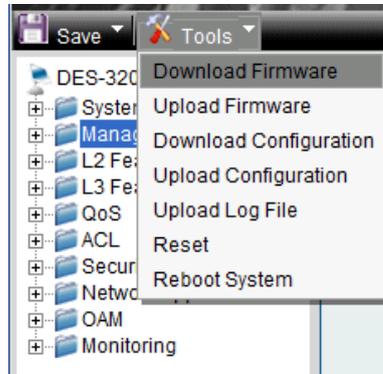
The 'Download Firmware' dialog box has three radio buttons: 'Download Firmware From TFTP' (selected), 'Download Firmware From FTP', and 'Download Firmware From HTTP'. Below these are input fields for 'TFTP Server IP', 'Source File', and 'Destination File'. A 'Download' button is at the bottom right. There is also a radio button for 'IPv4'.

5. Enter the TFTP Server IP address.
6. Enter the location and name of the Source File on the TFTP server(ex. DES3200\_RUNTIME\_V4.00.020.had)
7. Click "**Download**" button.
8. Wait until the "Current Status" reaches 100% and shows "Done".

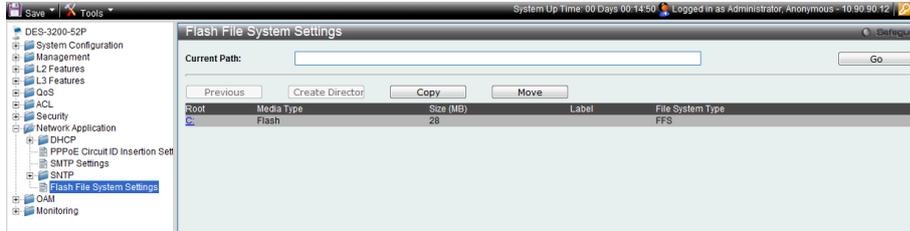
- To select the boot up image used for next reboot, click "**Network Application**" > "**Flash File System Settings**" in the function tree. Enter the Current Path string and click the Go button or click the **C:** to enter "Flash File System Setting- Search for Drive" window.

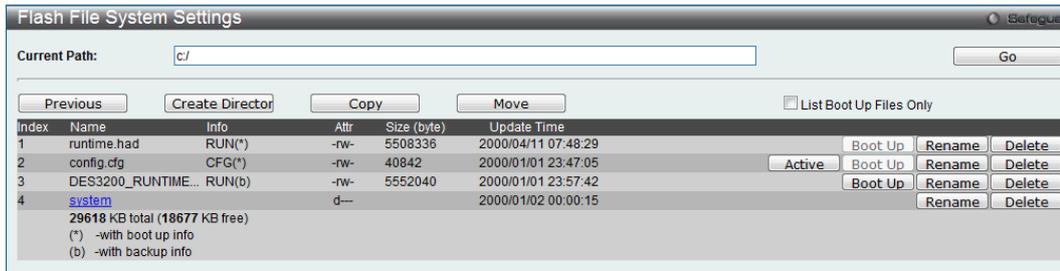
- Click corresponding "**Boot UP**" button to specify the firmware that will be used for next and subsequent boot up.

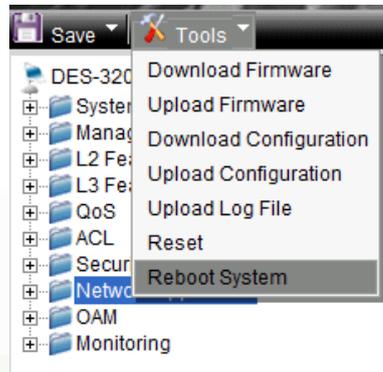
- To reboot the switch, select **Tools > Reboot System** from the banner.

- Select "**Yes**" and click "**Reboot**" button to reboot the switch.

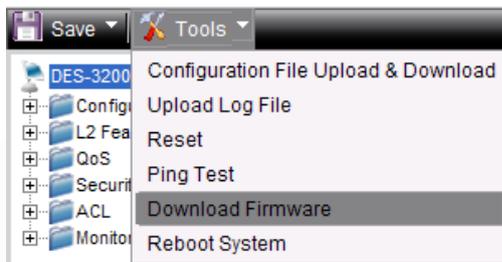
13. Connect a workstation installed with java SE runtime environment to any switch port of the device.
14. Open the web browser from the workstation and enter the IP address of the switch. The switch's default IP address is 10.90.90.90.
15. Enter administrator's username and password when prompted. It should be noted that the username and password are blank by default.
16. To update switch's firmware or configuration file, select **Tools > Download Firmware** from the banner.

17. Enter the TFTP Server IP address.
18. Enter the name of the firmware file located on the TFTP server.
19. Select the Image ID you would like to store the firmware file.
20. Click "**Download**" button.
21. Wait until the "File Transfer" status reaches 100% and the "Program Firmware" status shows "completed".
