**Firmware Version:** v1.03.B013  
**Prom Code Version:** v1.00.B007  
**Published:** 2009/3/20

These release notes include important information about D-Link switch firmware revisions. Verify that these release notes are correct for your switch:

## Revision History and System Requirement:

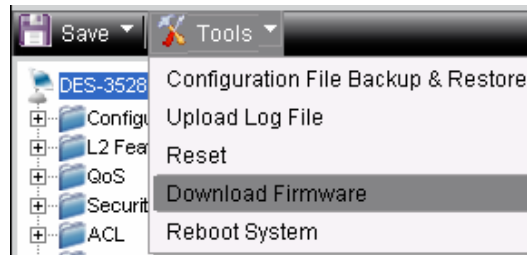
1. Connect a workstation with java SE runtime environment to any switch port of the device.
2. Open the web browser of the workstation and enter the IP address of the switch. The system default IP address is 10.90.90.90.
3. Enter administrator's username and password, which are blank by default.
4. To update the switch's firmware or configuration file, select **Tools > Download Firmware**

on the banner.

5. Enter the TFTP Server IP address.
6. Enter the name of the firmware file located on the TFTP server.
7. Select the Image ID you would like to store the firmware file.
8. Click "**Download**" button.
9. Waiting for File Transfer to reach 100% and Program Firmware status completed.
