Firmware Version: 1.10.005
Boot Code Version: 1.00.011
MIB Version: 1.00.008
D-View Module Version: 1.0.0.7
Published: Feb. 23, 2012

These release notes include important information about D-Link switch firmware revisions. Please verify that these release notes are correct for your switch:

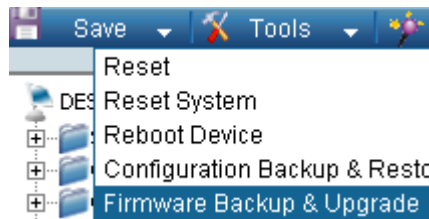
1. Connect a workstation installed with java SE runtime environment to any switch port of the device.
2. Open the web browser from the workstation and enter the IP address of the switch. The switch's default IP address is 10.90.90.90.
3. Enter administrator's password when prompted. The password is **admin** by default.
4. To update switch's firmware or configuration file, select **Tools > Firmware Backup & Upgrade** from the banner.

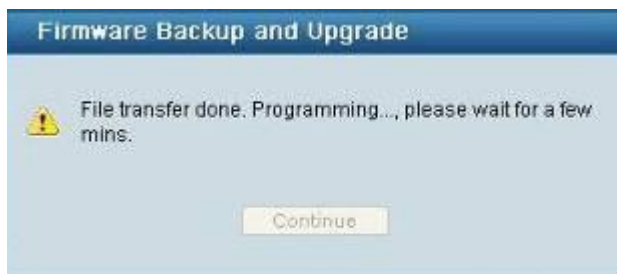
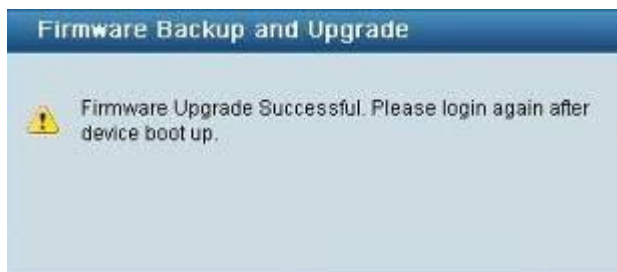
e. Wait until the "Firmware Upgrade Successful" message pops up and login again after device boots up.

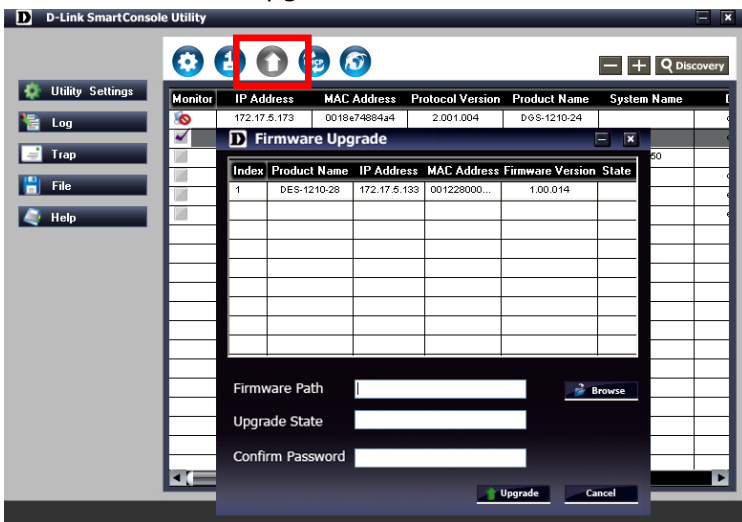
4. Click Firmware Upgrade button
