Firmware Version: V1.20.011
Prom Code Version: V1.00.012
Published: 2015/5/2

These release notes include important information about D-Link DGS-1510 Series firmware revisions. Please verify that these release notes are correct for your switch:

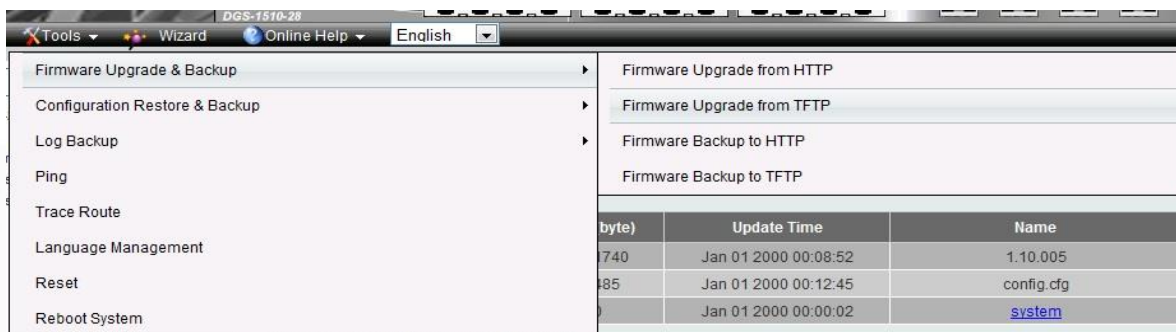
4. To update switch's firmware or configuration file via TFTP, select **Tools > Firmware Upgrade & Backup > Firmware Upgrade from TFTP**.

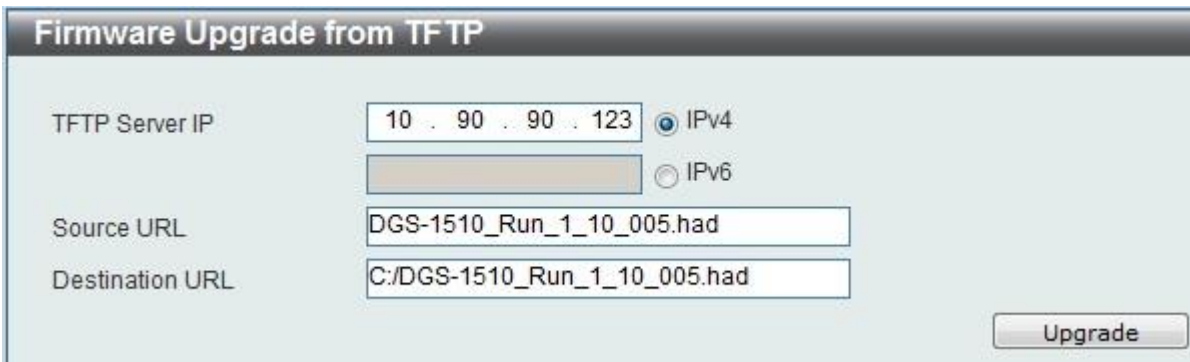
5. Enter the TFTP Server IP address.
6. Enter the name of the firmware file located on the TFTP server.
7. Enter the destination path and the desired file name.
8. Click "**Upgrade**" button.

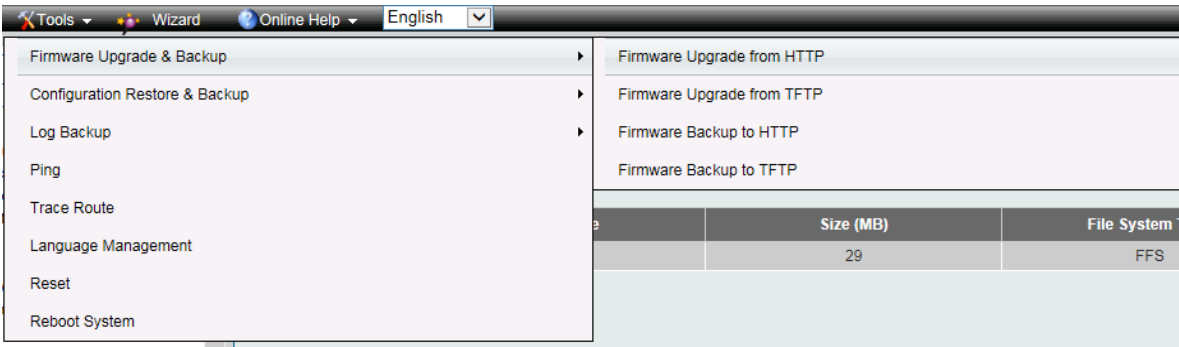
- 9. Transmission will start and wait until the status is completed by displaying **100%** complete.
- 10. Alternatively, the switch's firmware or configuration file can also be upgraded via HTTP, select **Tools > Firmware Upgrade & Backup > Firmware Upgrade from HTTP**.

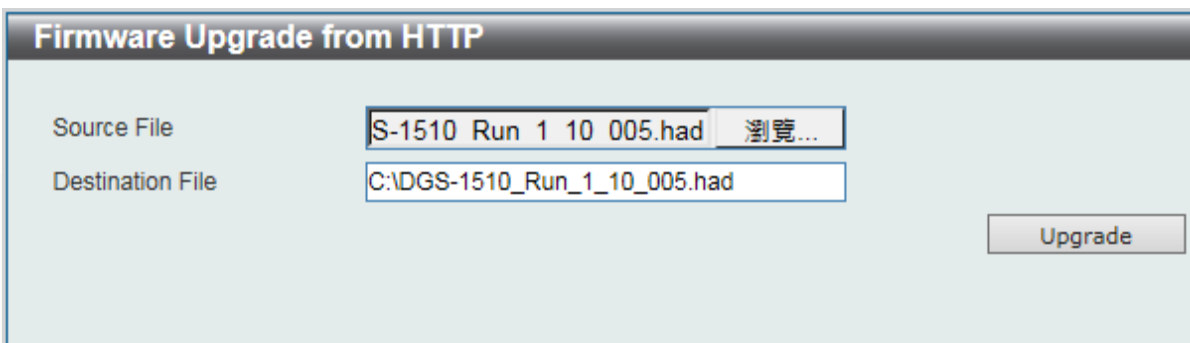
- 11. Enter the source and destination file.
- 12. Click "**Upgrade**" button.

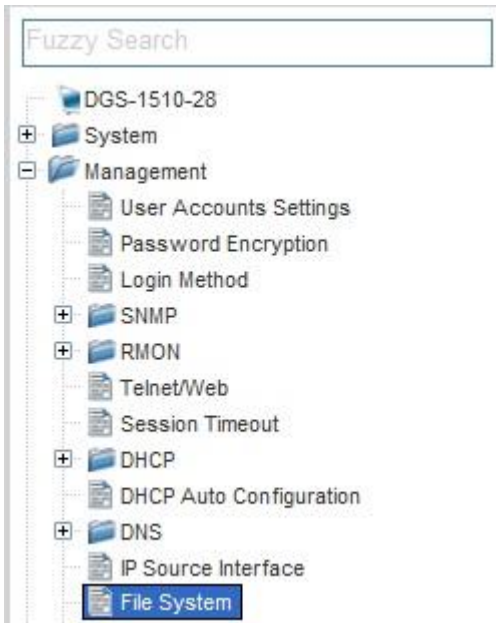
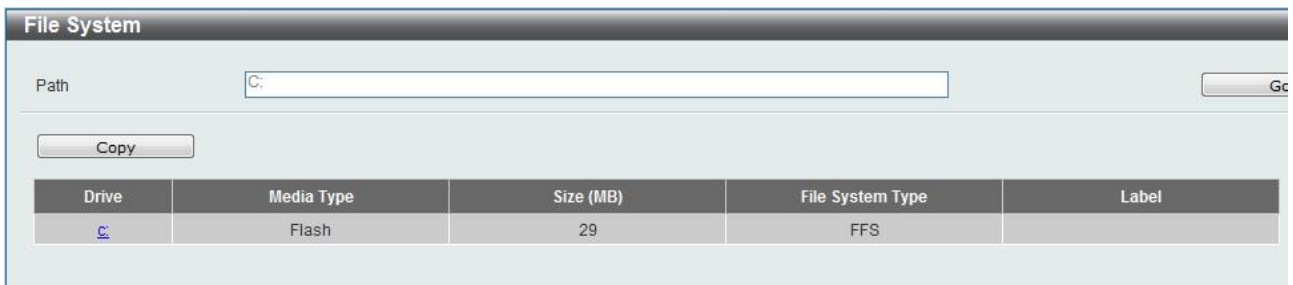
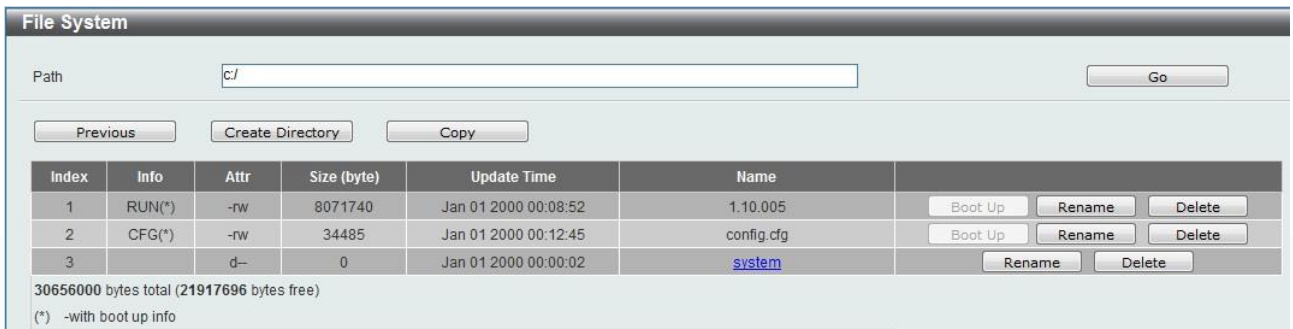
- 13. Transmission will start and wait until the status is completed by displaying **100%** complete.
- 14. To select the boot up image used for next reboot, click **Management > Flash System** in the function tree and then click the **C:** drive name. When you see the files list, click corresponding **Boot Up** button to specify the firmware that will be used for next and subsequent boot up.

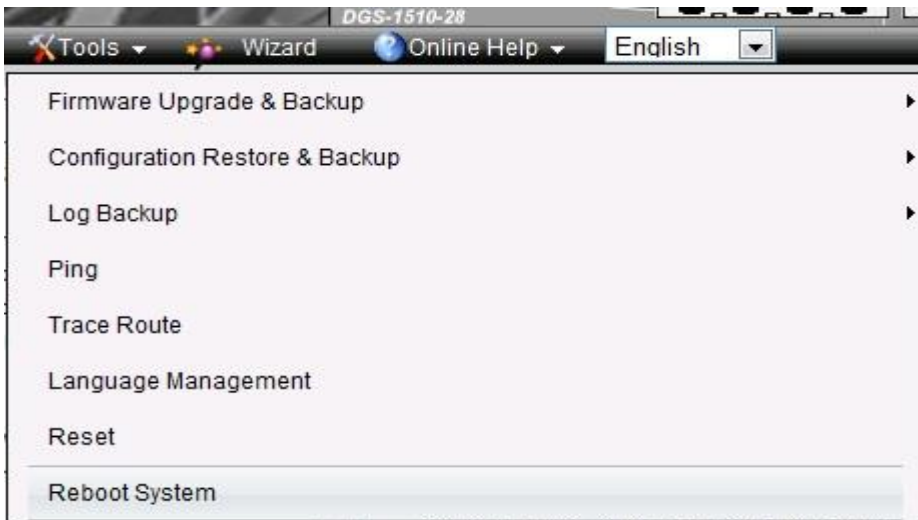
15. To reboot the switch, select **Tools > Reboot System** from the banner.

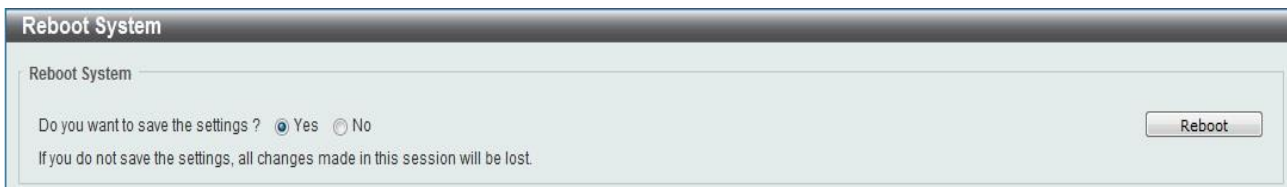
16. Select **Yes** and click **Reboot** button to reboot the switch.
