Firmware Version: v 4.00.015
Prom Code Version: v 3.00.501
Published: Mar. 25, 2014

These release notes include important information about D-Link switch firmware revisions. Please verify that these release notes are correct for your switch:

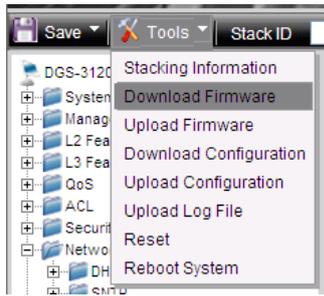
- To update switch's firmware or configuration file, select **Tools > Download Firmware** from the banner.

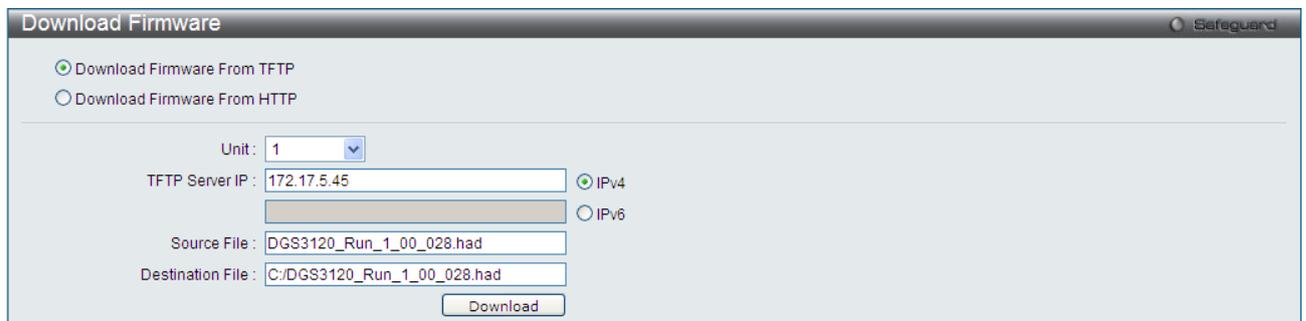
- Enter the TFTP Server IP address.
- Enter the name of the firmware file located on the TFTP server.
- Enter the destination path and the desired file name.
- Click **Download** button.

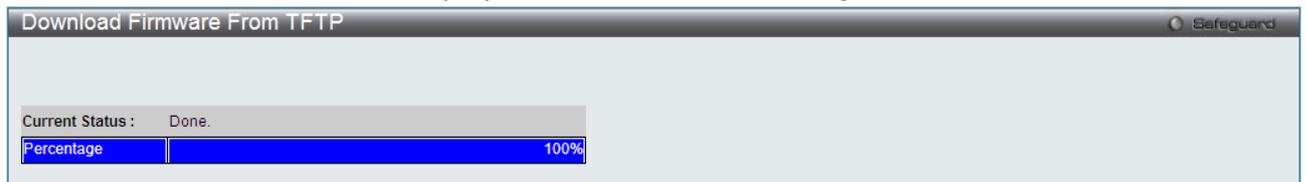
- Wait until the Current Status displays **Done** and the Percentage shows **100%**.

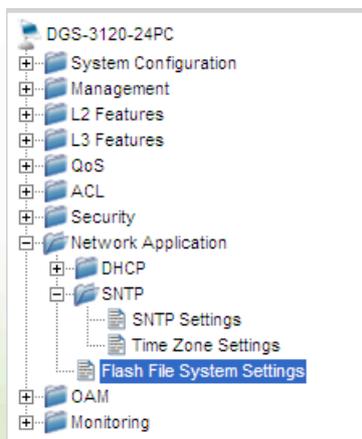
- To select the boot up image used for next reboot, click **Network Application > Flash File System Settings** in the function tree and then click the **C:** drive name. When you see the files list, click corresponding **Boot Up** button to specify the firmware that will be used for next and subsequent boot up.

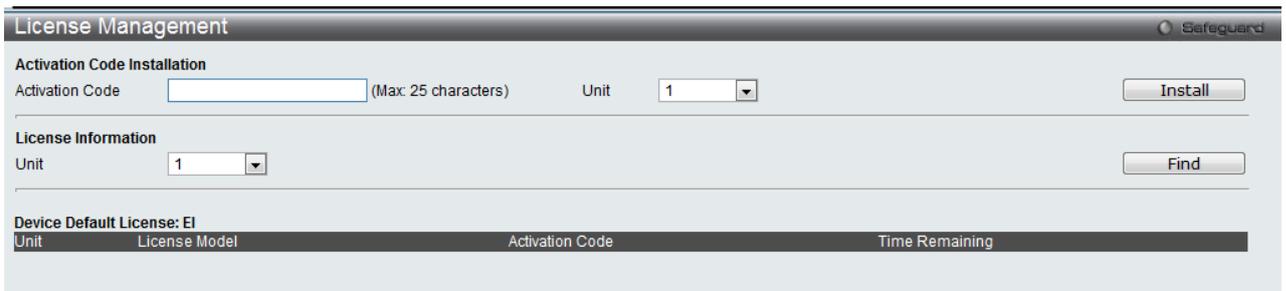
5. Enter the Activation Code and select unit of stack then click **Install** to activate the assigned switch.
