**可靠度試驗報告**  
*Reliability Test Report*

<b>試驗項目</b>	<b>Low / High Temperature</b>	<b>測試品</b>	<b>VS2101</b>	<b>Record No.</b>	<b>QRP-0203-03HLe</b>
<b>Test Item</b>	<b>Boot-Up Test</b>	<b>E.U.T.</b>		<b>Issuing Date</b>	<b>08/12/2002</b>

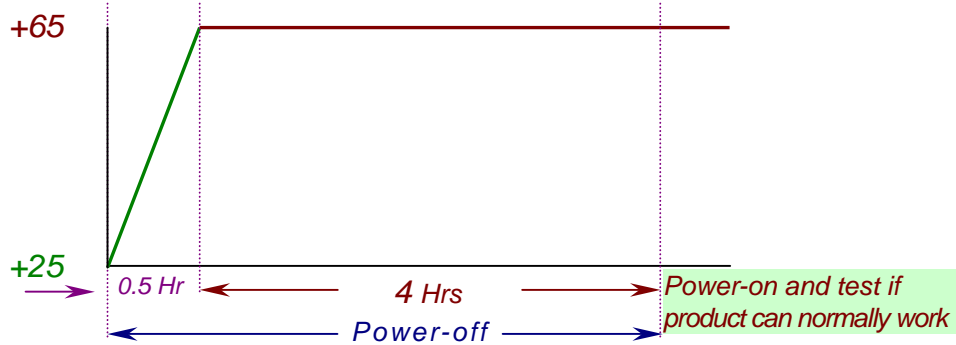
b. High temperature: (+65 , After 4 Hrs. of power-off, product can normally work when booting-up)

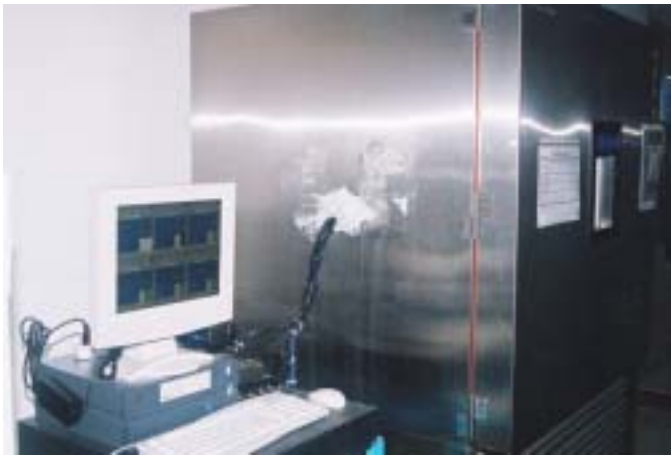
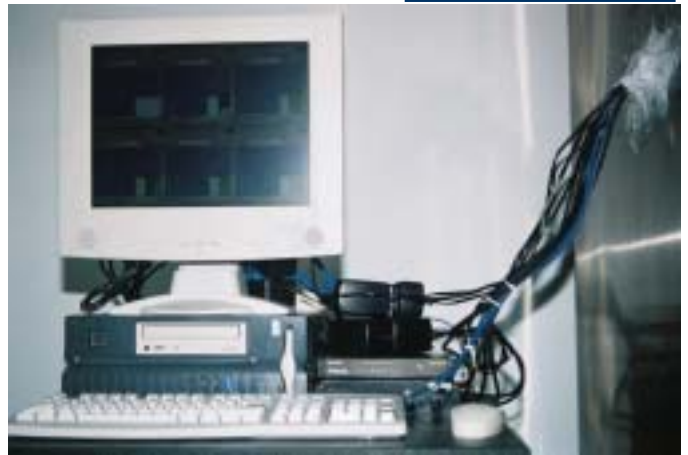
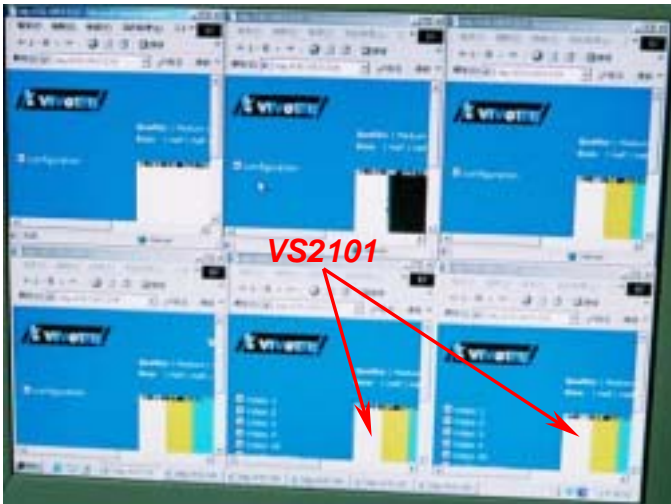
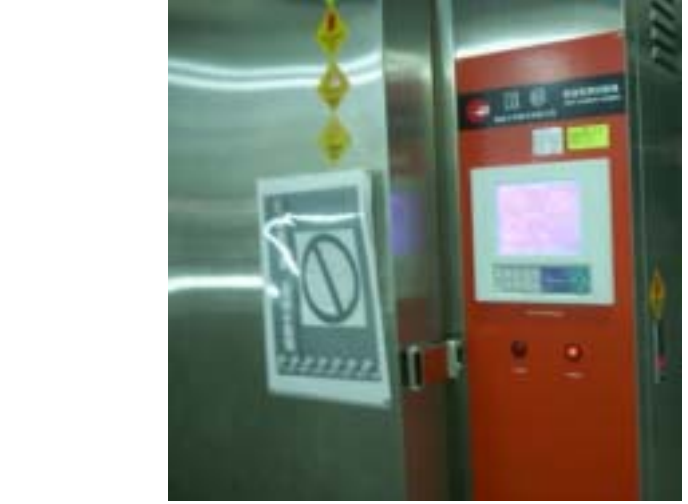
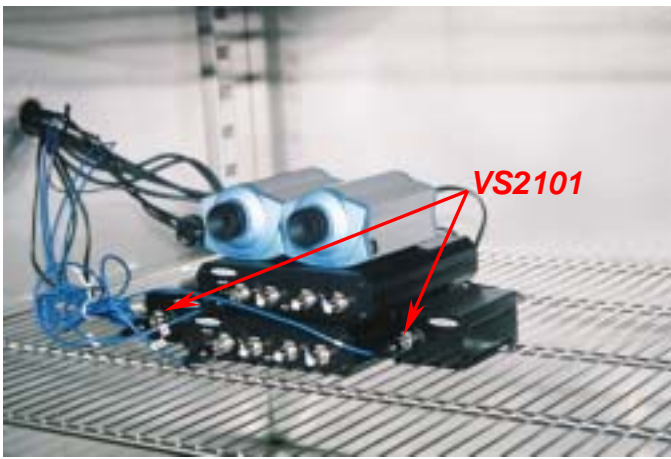
Date	Time	Check	Remark
Begin	08/08	09:27am	Check	
End	08/08	03:45pm		
0002D1000257 0002D10002BB	Test time: 5:18			Temperature & Humidity Chamber.

Date	Time	Check	Remark
Begin	08/09	09:35am	Check	
End	08/09	03:15pm		
0002D1000257 0002D10002BB	Test time: 5:40			Force Air Oven.

Environment of the E.U.T. (See Attachment 1 picture)

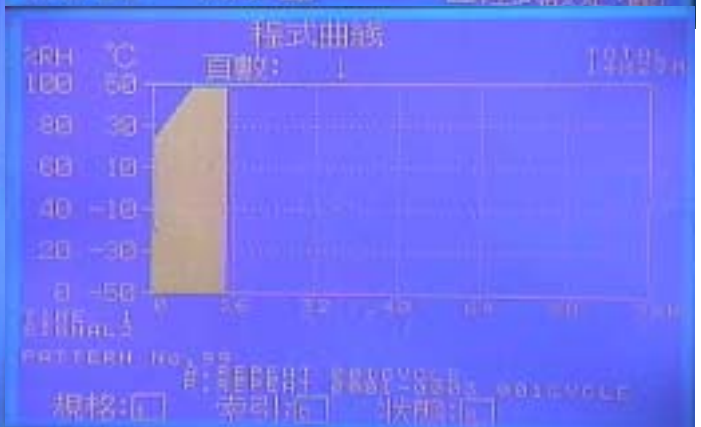
09H08D02Y    狀態畫面

PATTERN NO. 99 STEP 0010 ( 720step)  
 PATTERN STEP SET No. 0001  
 ALL STEP 0010 STEP 0010 STEP 0010  
 PART STEP 0010 STEP 0010 STEP 0010  
 HEAT 0001-0004STEP 0010CYCLE

STEP	°C	%RH	HH:MM	WAIT	TS1	TS2
1	025.0	030.0	00:30	—	—	—
2	025.0	030.0	00:30	W	—	—
3	065.0	000.0	12:00	—	—	—
4	065.0	000.0	12:00	W	—	—
5						
6						
7						
8						
9						
10

温度                      相对湿度  
 PU 65.00 °C    PU 90.0 %RH  
 SU 65.00°C    SU 90.0%RH  
 NET 62.00°C

PATTERN NO. 99    STEP NO. 0010  
 TOTAL TIME 14:28    STEP TIME 08:02
